DOUGLAS REPORT DAC-56499

NARRATIVE END ITEM REPORT

SATURN S-IVB-208

JUNE 1968

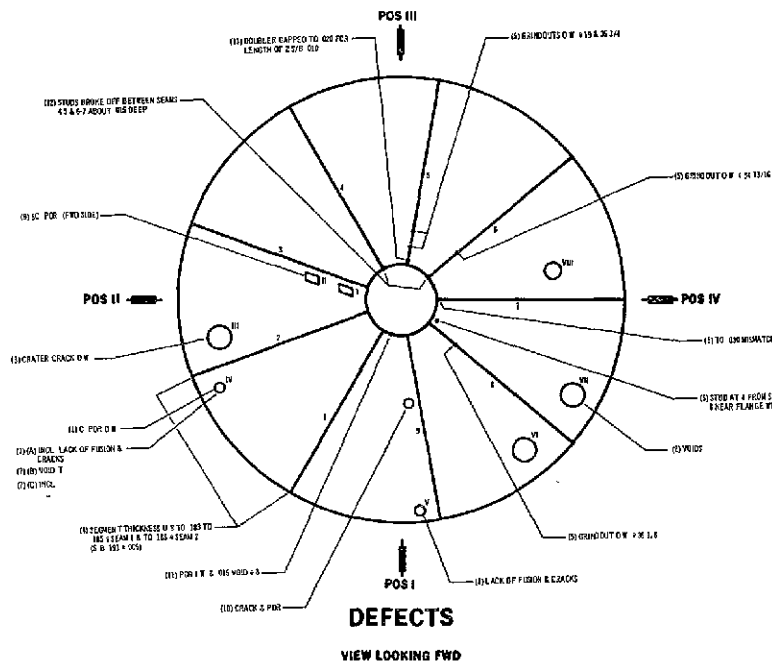
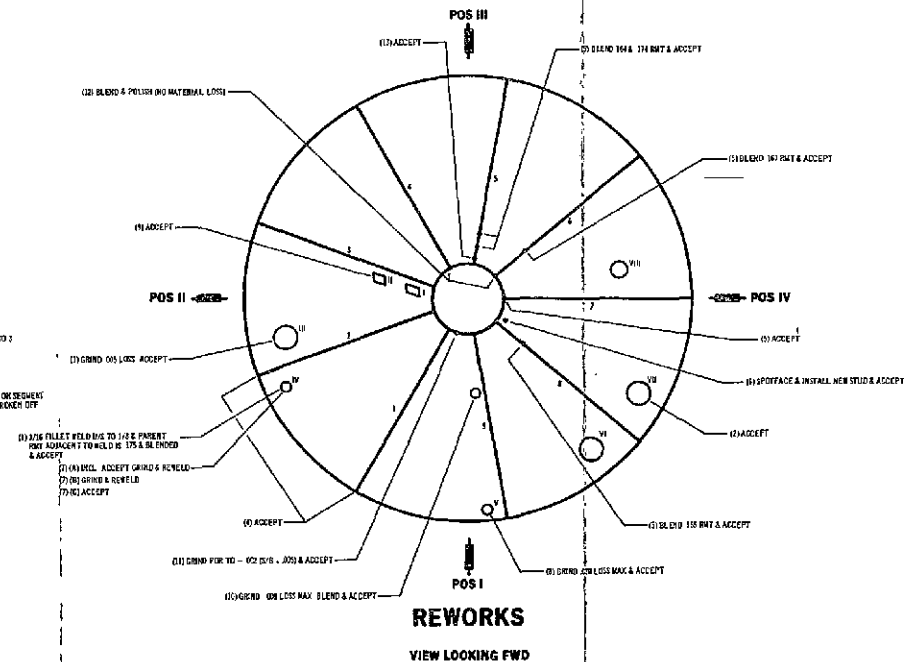
Chart 6. Aft Face Meridian Welds

ITEM	FABR NUMBER	INITIATION DATE	DEFECTS	REWORKS REQUIRED	HOW REWORKED	REWORKS
(1)	AFTD102 F.F.	11-20-65	1	1	N/A	0
(2)	AFTD103 A.B.	12-7-65	1	0	N/A	0
(3)	AFTD104 B.B.	12-7-65	1	1	N/A	0
(4)	AFTD105	12-10-65	2	0	N/A	0
(5)	AFTD106 NEW	12-22-65	5	4	N/A	0
(6)	AFTD108 STD	1-5-66	1	1	STUD WELDER	1
(7)	AFTD107 F.F.	1-7-66	9	2	MANUAL TIG	2
(8)	AFTD109 G.W.	1-7-66	4	4	N/A	0
(9)	AFTD110 B.W.	1-7-66	1	3	N/A	0
(10)	AFTD111 B.W.	1-7-66	3	3	N/A	0

ITEM	FABR NUMBER	INITIATION DATE	DEFECTS	REWORKS REQUIRED	WELDING REWORK	REWORKS
(11)	AFTD112	2-14-66	1	1	N/A	0
(12)	AFTD113	2-24-66	2	2	N/A	0
(13)	AFTD114	3-10-66	1	0	N/A	0
